ENERGY AUDIT REPORT

DEPARTMENT OF CUSTOMS AND INLAND REVENUE OFFICES, LUGANVILLE- SANTO

THE DEPARTMENT OF ENERGY

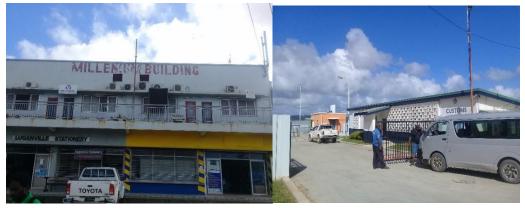
Fig 1: CUSTOMS DEPARTMENT buildings, Luganville

- -The customs department main office in Luganville (Santo) is located in the Millennium as shown on Figure 1a: Millennium Building

Figure 1 b.
- **Figures Description:** Figure 1a: Millennium Building Figure 1 b shows the operations office that is located within the premises of the Luganville International wharf and it is less old in contrast to Figure 1a: Millennium Building Figure 1 b.
- **Observation:** the building is quite old which suggests that its electrical system (wiring, equipment) is also old. Arrangement of rooms and electrical appliances have huge impact on monthly Bill.
- **Suggestion:** old systems are less efficient and may result in unnecessary power

Figure 1a: Millennium Building

Figure 1 b: Main wharf

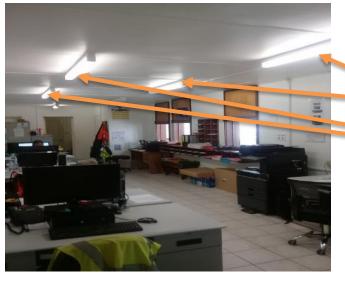
Figure 2: Example of lack of proper lighting management

- a. Observation(s)/Issue(s):
- It has been observed there are a lot of unnecessary lights in one single room (see Figure 2)
- Too many lights are assigned to 1 switch.

i.e. "Poor management of lightings"

Too many lights in one room,

- Turn OFF lights when not used.
- -Reduce the number of lights per switch, to better manage lighting.
- -Reduce the number of lights per room.

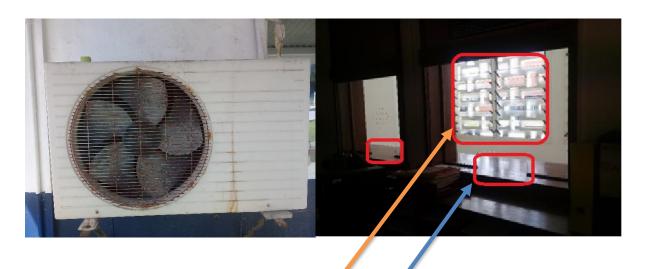
Figure 4: Air conditioners used within the CUSTOMS DEPARTMENT building.

- a. Observation(s)/Issue(s):
- Brand & model not consistent throughout the building which is expensive for maintenance.
- Officers leaving the door open when entering and exiting the room where the air conditioner is located.
- air conditioning contributes to about 62% of the overall power consumption of the buildings.
- windows and doors of the air conditioned rooms not sealed properly i.e. using louvers is 'highly Not recommended'.

This needs to be <u>replaced with Glass windows</u> and sealed properly to minimise power consumption of air conditioning to reduce electricity bill.

- Use same brand throughout (cheap for maintenance cost)
- It is recommended that the air conditioners be serviced quarterly.
- use sealed glass windows and sealed glass doors.
- always close door when entering/exiting an air-conditioned room (put a notice on the front and back of the door as a reminder).
- Keep and maintain the temperature at 23 °C during summer and occasionally used in winder.
- Switch OFF when not in use but avoid reducing to a lower temperature and leave it ON
- Use electric fan whenever possible.
- Use outside breeze when possible, should the air conditioner be turned off completely to minimize the cost of electricity.
- Installation of correct sizing of air conditioner in the rooms.
- All installed air conditioners should be service at least twice or three times a year.

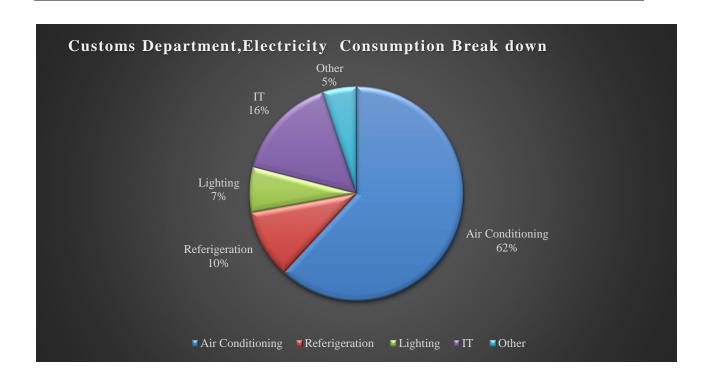
Analysis of the chart in Figure 3.

- -Air conditioning is responsible for high significant proportion of the total energy consumption followed by lightings.
- There is variation among the appliance due to their arrangement within the building, the hours in which they operate and the rate at which they consume electricity.
- There is variation among the appliance due to their arrangement within the building, the hours in which they operate and the rate at which they consume electricity.
- It is evident that avenues need to be utilised to better managed electricity consumption of such appliances.
